Home Inspection Report

2112 Rush Street, Redmond, WA 98052

Wednesday May 1, 2019

2169

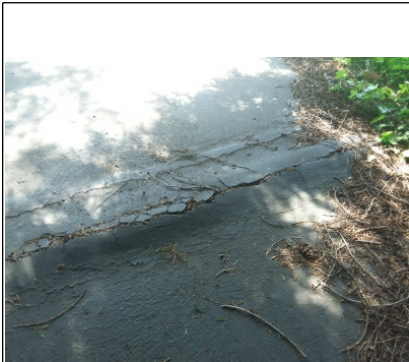
Asphalt driveway has heaved

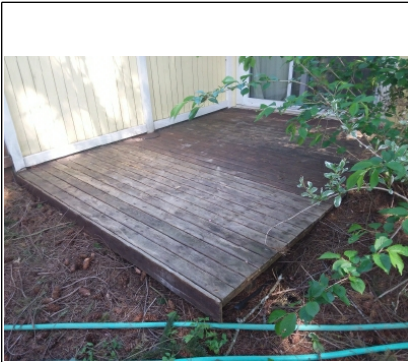
- Condition** ☒ Satisfactory ☐ Marginal ☐ Poor ☒ Wood in contact with soil ☐ Improper Attachment To The House
- Hand Rail** ☐ Satisfactory ☐ Marginal ☐ Poor ☒ N/A ☐ Missing ☐ Loose ☐ Recommend Repair
☐ Safety Hazard ☐ Not of grippable type
- Finish** ☒ Treated ☐ Painted/Stained ☐ Composite ☐ Safety Hazard ☐ Not Applicable
☐ Recommend Replacing Rotted Wood ☐
- Comments** Wood deck is in contact with soil and in need of refinishing, recommend removing all Earth to wood contact and sealing wood with quality wood sealant

Deck in contact with soil

Wood deck is in contact with soil and in need of refinishing, recommend removing all Earth to wood contact and sealing wood with quality wood sealant

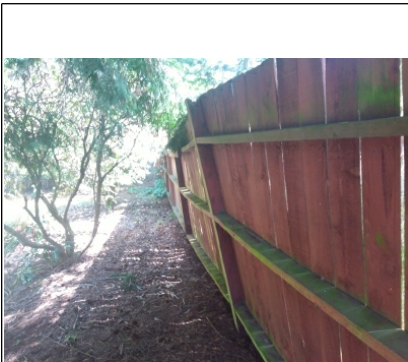
- ☐ Not evaluated ☐ None ☐ Not Installed
- Type** ☐ Brick ☐ Block ☒ Wood ☐ Metal ☒ Chain Link ☐ Vinyl ☐ Rock ☐ Wire
- Condition** ☒ Satisfactory ☐ Marginal ☐ Poor ☐ Typical cracks ☐ Loose Blocks/Caps
☐ Broken Or Missing Pickets ☐ Dry Rot
- Gate** ☐ N/A ☒ Satisfactory ☐ Marginal ☐ Poor ☐ Dry Rot ☐ Planks missing/damaged Operable: ☒ Yes
☐ No
- Comments** Neighbors wood fence is collapsing onto property, recommend contacting neighbor and sharing the cost of replacing the fence

Neighbors wood fence is collapsing

Neighbors wood fence is collapsing onto property, recommend contacting neighbor and sharing the cost of replacing the fence

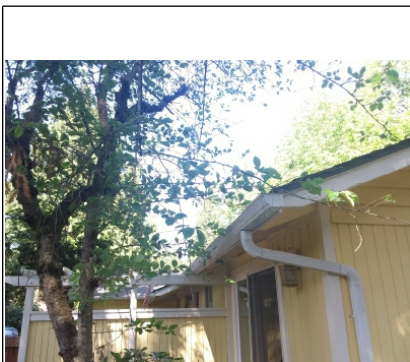
Tree in contact with home

Comments Recommend trimming trees so it doesn't come into contact with the home and provide rodents access to the roof

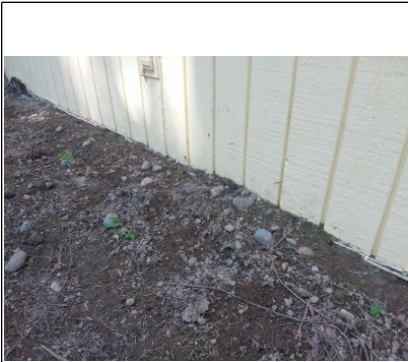
Siding in contact with soil

Comments Some siding in contact with the soil, recommend to remove all Earth to wood contact

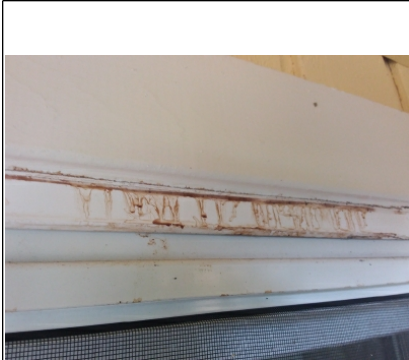
Cracked caulking present above deck sliding glass door

Some cracked caulking present with moisture stains above deck sliding glass door, recommend to recaulk with quality exterior silicone based caulk where needed and cleaning moisture stains from above the door

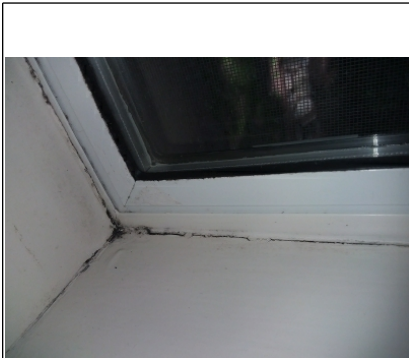
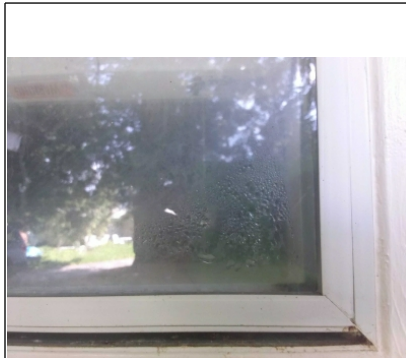
Aluminum framed windows appear original to the home, multiple window show signs of compromised seals, wood window sills have moisture stains, possibly from sweating aluminum frames, recommend to monitor and replace as needed

Moisture stains present

Moisture trapped between window panes

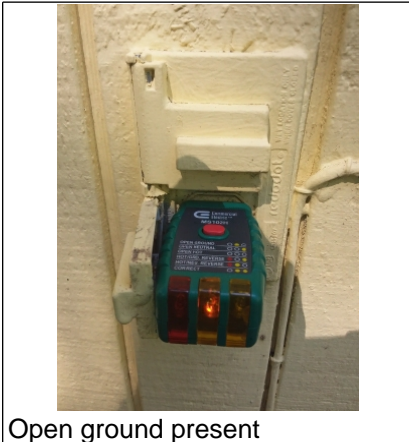
Open ground present

Comments Open ground and non GFCI protected exterior plug present, recommend to install GFCI protected plug

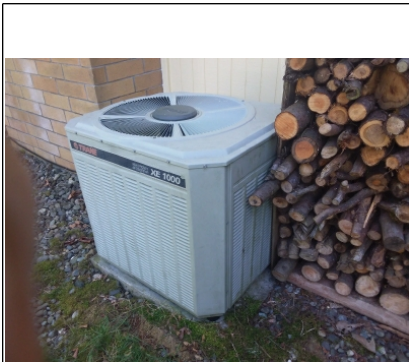
Firewood stacked up against compressor

Firewood stacked against exterior air conditioning compressor, recommend removing all wood to allow for proper ventilation

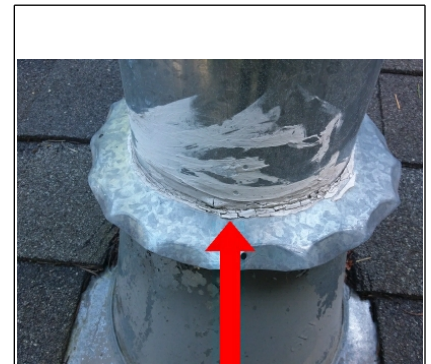
Deteriorating caulking present

Comments Cracked caulking present on chimney flashing, recommend caulking as needed

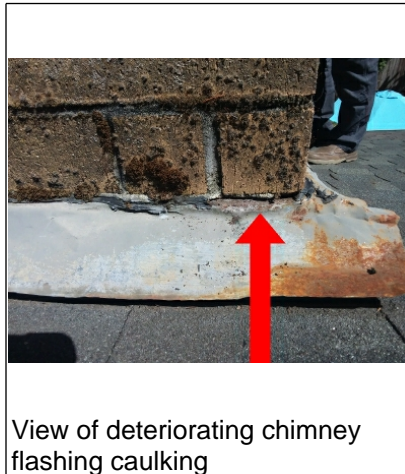
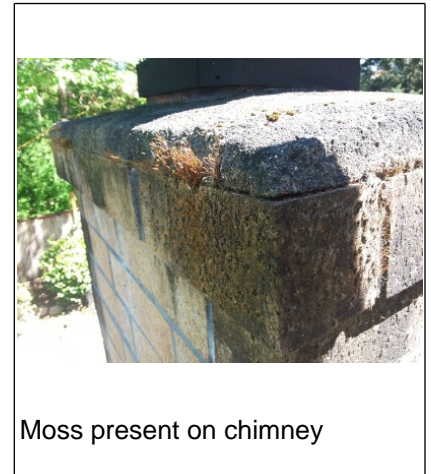
View of deteriorating chimney flashing caulking

Moss present on chimney

Comments Masonry chimney has some moss present with deteriorating chimney flashing caulking present, recommend cleaning moss and recaulk flashing as needed

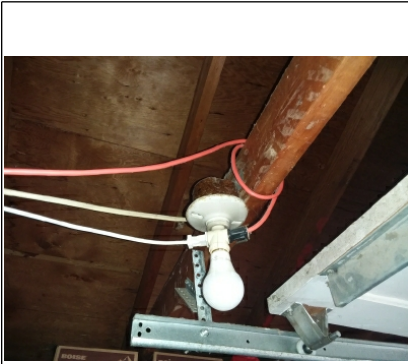
Extension cords to use for permanent wiring

Comments extension cords used for permanent wiring in the garage, recommend a licensed electrician to install dedicated electrical outlets where needed

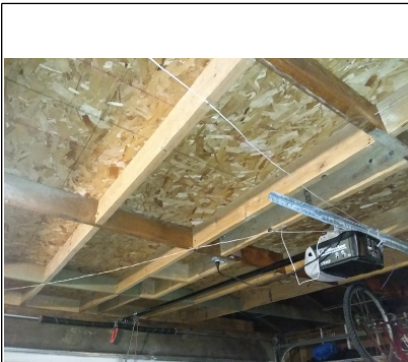
Sagging roof rafters from overhead storage

Sagging roof rafters present from use of homeowner improvised overhead storage, recommend only light weight minimal use

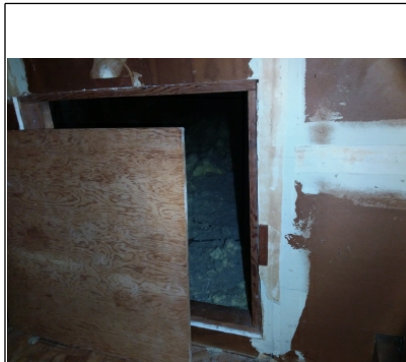
Attic access door is not fire rated

Comments Attic access door located in the garage is not fire rated with some holes present in garage firewall, recommend patching holes and covering access door with 5/8 sheetrock

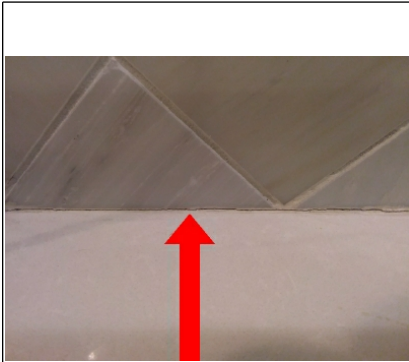
Backsplash needs caulking

Comments Kitchen tile backsplash needs caulking

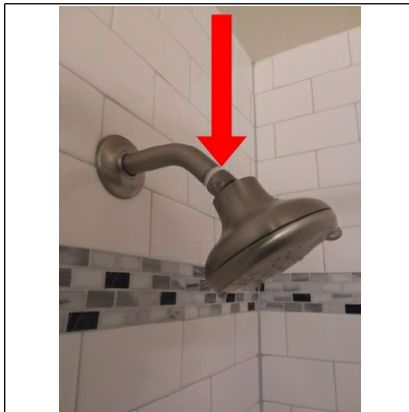
Shower faucet leaks

Bathroom shower faucet is leaking, recommend applying new Teflon tape and tightening

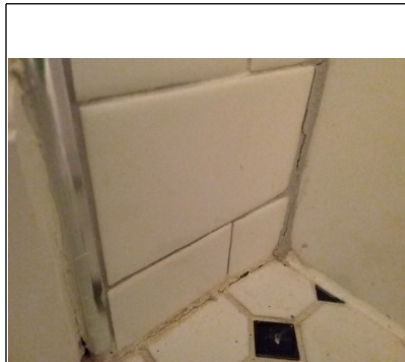
Cracked grout present

Both bathroom shower tile grout has cracked, recommend regrouting as needed

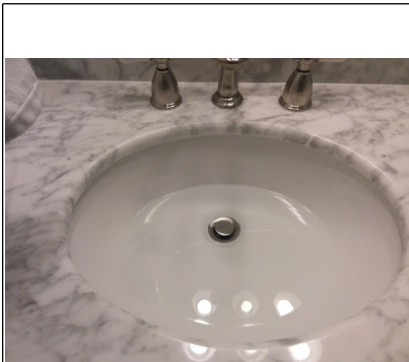
Sink slow to drain

Master bathroom sink is slow to drain, recommend drain opener to see if that solves the problem

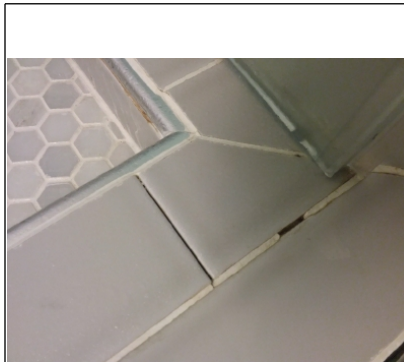
Cracked tile grout present

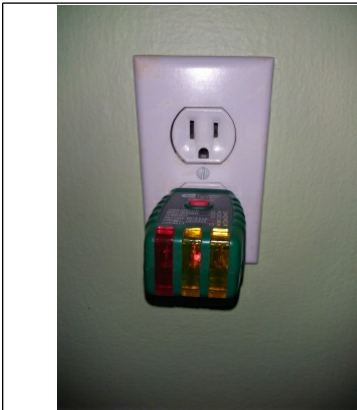
Open ground present

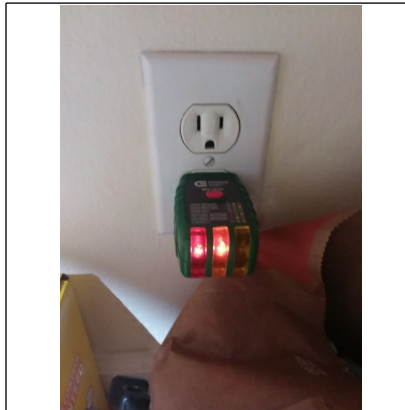
Reverse polarity present

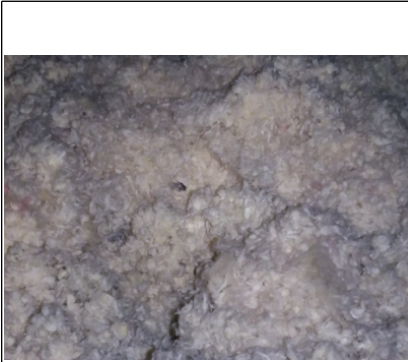
Rodent trails with burrowing activity present

Rodent droppings and trails with burrowing activity in ceiling insulation present in the attic, recommend licensed pest inspector to evaluate

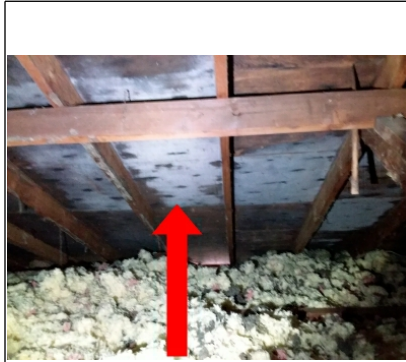
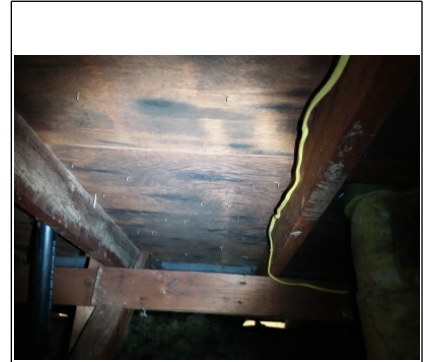
Organic growth present on roof underlayment

Dark staining present possible mold

Light and dark organic growth present on plywood roof underlayment in the attic, recommend licensed mold inspector to evaluate

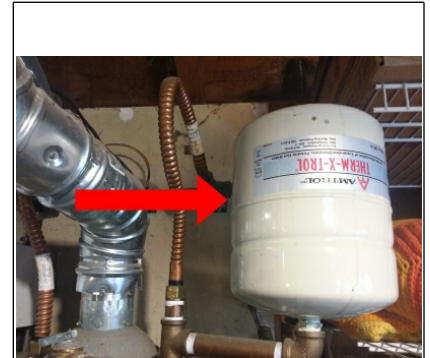
Leaking water heater expansion tank

Comments Water heater expansion tank internal rubber diaphragm is leaking, gas vent pipe is two different types of piping held together by sheet metal screws, recommend licensed plumber to evaluate and repair

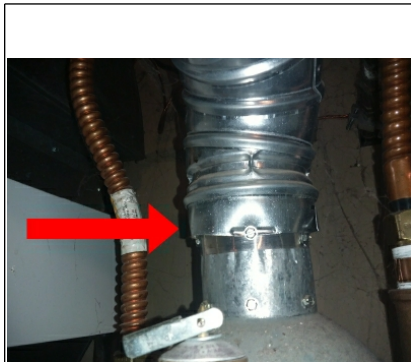
Improper attachment of water heater vent pipe

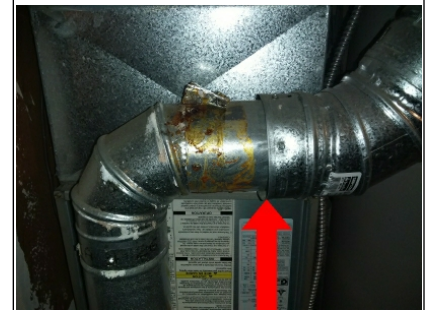
Different types of furnace vent ducting used

Comments Soot and effervescence present in the furnace with two different types of gas vent ducting used with some deterioration present, recommend license HVAC technician to evaluate, clean and repair as needed

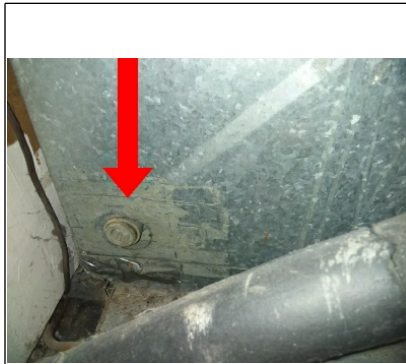
Warm air blowing out of secondary drain hookup

Comments Air conditioner evaporator and condenser are over 30 years old, warm air leaking out of multiple locations of evaporator located under the furnace, recommend license HVAC technician to evaluate when servicing the furnace

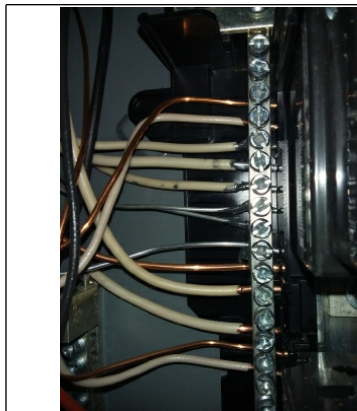
View of solid aluminum core wires

Comments electrical service panel appears to have been installed unpermitted, solid core aluminum wires are present for branch wiring, evaluation of the electrical system by an electrician who has knowledge of and experience with solid conductor aluminum wiring is recommended

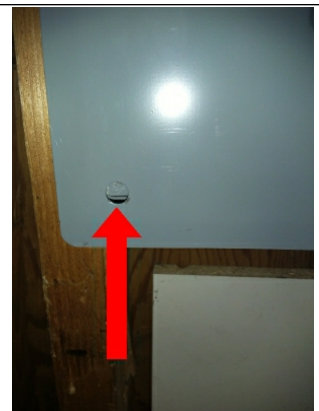
Missing dead front screws

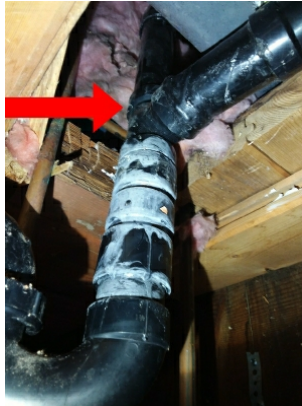
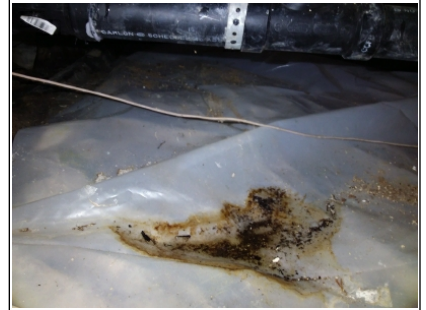
Improperly attached ABS bathtub drain pipe

Small puddle of water present under improperly attached drain pipes

Comments Deteriorating cast iron waste water drain pipe with puddle of raw sewage present in the crawl space, improperly installed ABS bathtub drain pipes with small leak present, recommend licensed plumbing contractor to evaluate

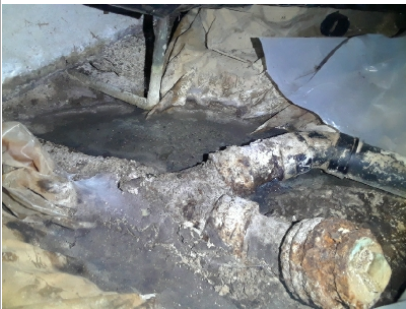
Deteriorating cast iron waste water drain pipe with raw sewage

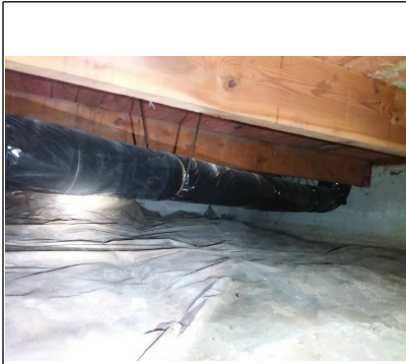
Some crawl space access limited by HVAC ducting

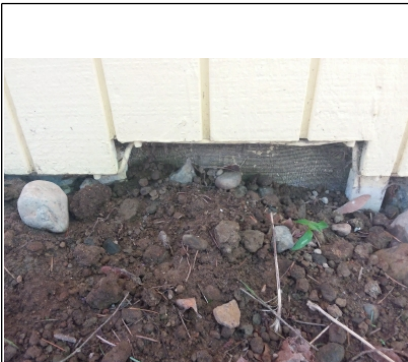
Block crawl space wall vents

Comments Some crawl space exterior wall vents have soil piled up in them, recommend removing all obstructions to ensure proper crawl space ventilation
