Home Inspection Report

1276 145th Ave SE, Bothell, WA 98021

Wednesday April 10, 2019

2615

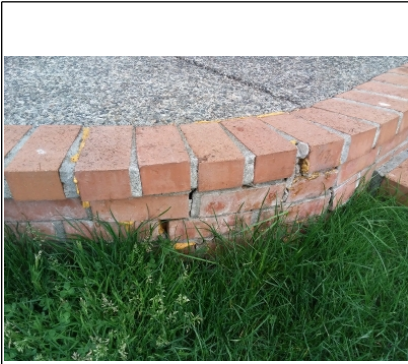
Cracked brick present

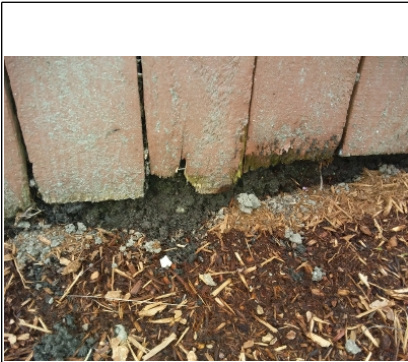
Dry rot present

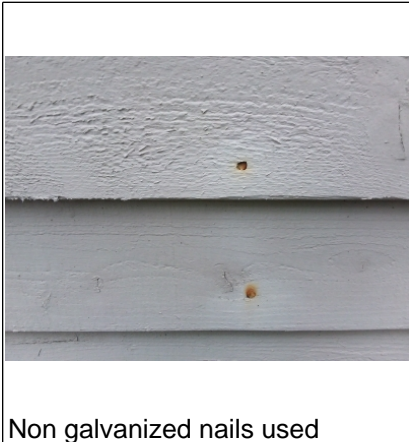
Non galvanized nails used

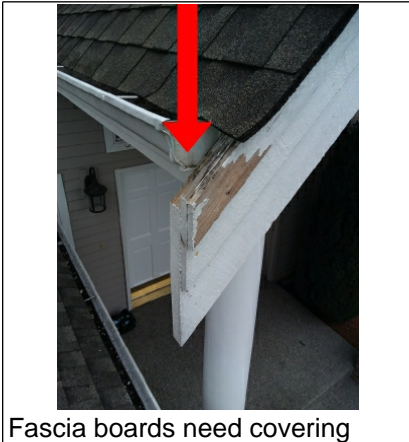
Comments Some fascia boards are missing roofing over the tails allowing moisture to cause damage and peeling paint, recommend licensed roofing contractor add flashing when maintaining the roof

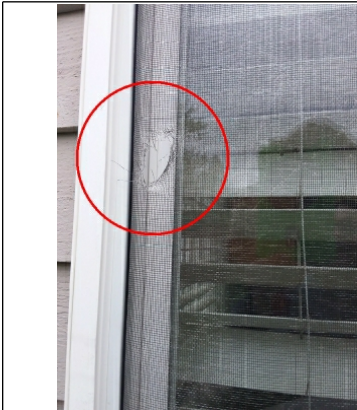
Damaged window screen

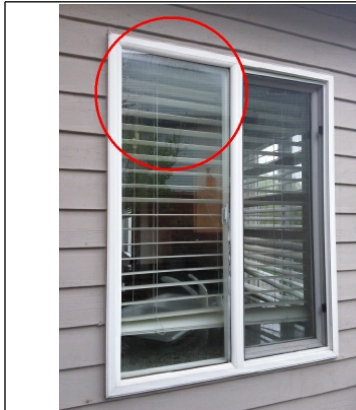
multiple window show signs of damaged window seals with fogging and moisture present between window panes, recommend budgeting for new windows and replacing as needed

Moisture between panes present

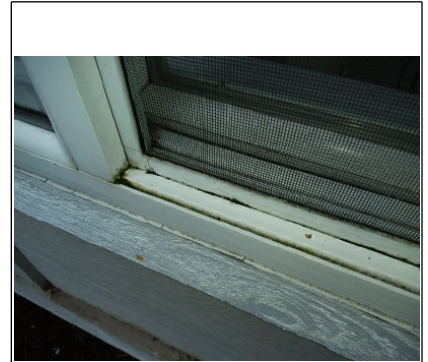
Debris and organic growth present in some window tracks/frames, recommend cleaning with a appropriate cleaner to prevent deterioration of windows

Growth present in window tracks

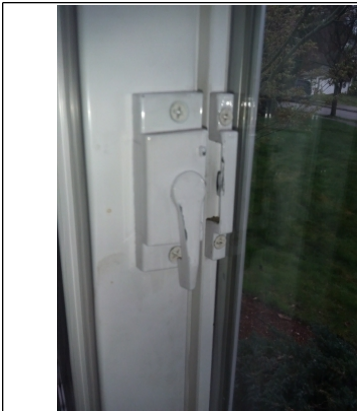
Misaligned lock set

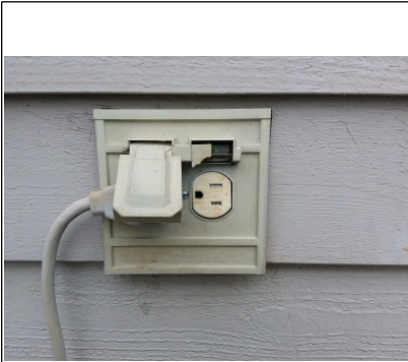
Comments Exterior electrical receptacle weather protection cover is damaged, recommend to replace

Damaged weather protection cover

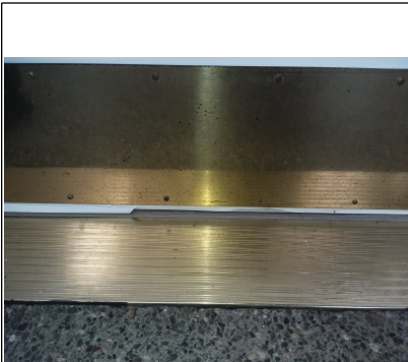
Comments Main entrance door weatherstripping is damaged, recommend to replace
 moisture trapped between window panes on sliding glass door

Damaged weather stripping on entry door

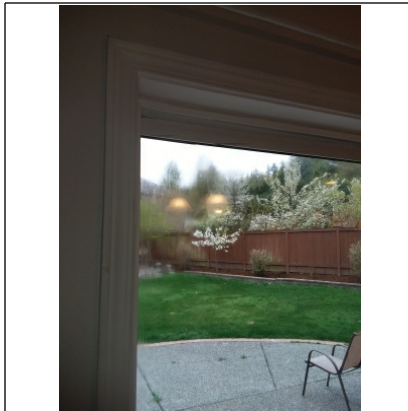
Moisture trapped between window panes

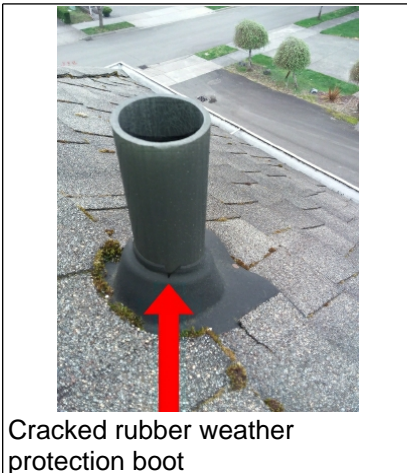
- ☐ Not Visible ☐ Not Present
Condition ☐ Satisfactory ☒ Marginal ☐ Poor ☒ Rubber Weather Protection Boots Cracked
Comments Plumbing vents on the roof have cracked rubber weather protection boots, recommend a licensed roofing contractor to repair as needed

Cracked rubber weather protection boot

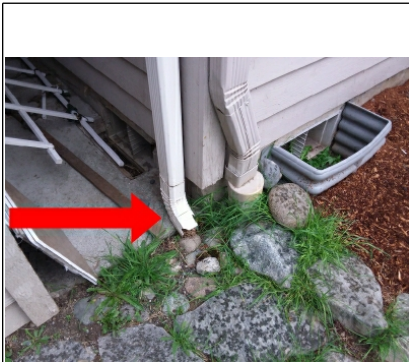
Gutter extension needed

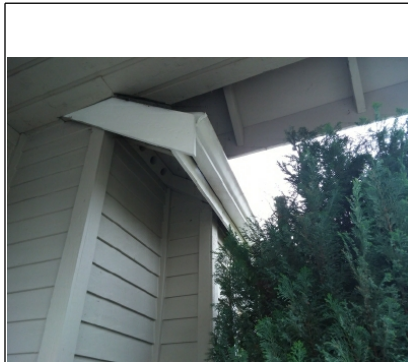
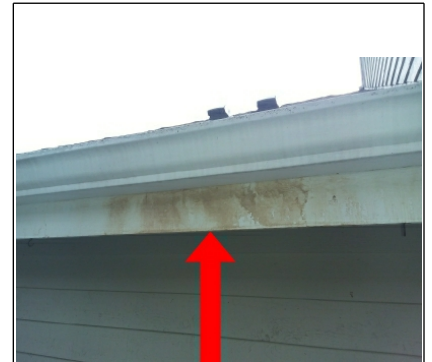
☐ None
Condition ☐ Satisfactory ☒ Marginal ☐ Poor ☐ Rusting ☐ Downspouts needed ☒ Recommend repair
☐ Recommend replace ☒ Needs to be cleaned ☒ Improperly Sloped ☐ Damaged
Material ☐ Copper ☐ Vinyl/Plastic ☐ Asphalt ☐ Rubber ☒ Galvanized/Aluminum Other: .
Leaking ☐ Corners ☐ Joints ☐ Hole in main run ☒ Leaks Multiple Locations ☐ No apparent leaks
Attachment ☐ Loose ☐ Missing spikes ☐ Improperly sloped ☒ Satisfactory
Extension needed ☐ North ☐ South ☐ East ☒ West ☐ N/A
Comments Gutter extensions needed to divert water from the roof at least 6 ft away from the home to prevent water intrusion into the crawl space
 Gutters are improperly sloped with standing water and multiple leaks present, recommend a licensed roofing contractor to evaluate, seal leaks and repair as needed

Leaking gutter

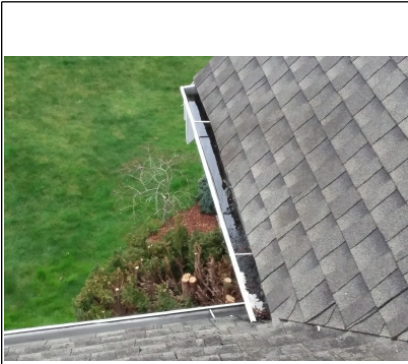
Gutters are improperly sloped with standing water present, with multiple leaks, recommend a licensed roofing contractor to evaluate, seal leaks and repair as needed

Standing water present in gutter

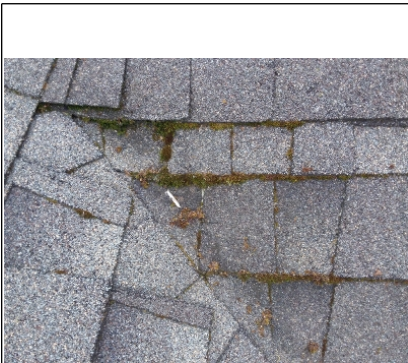
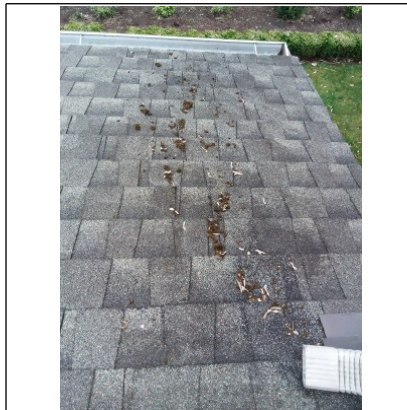
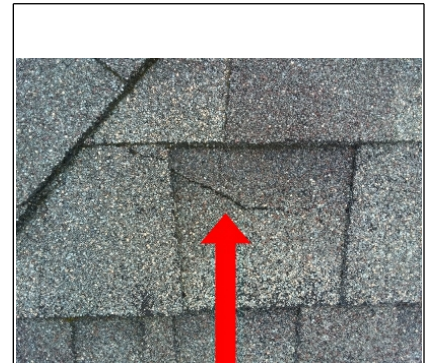
It appears that it has been some time since the roof has been serviced, excessive moss and damaged shingles present in multiple locations, recommend a licensed roofing contractor to evaluate, clean, and repair as needed

Moss present on roof

Debris present on roof

Cracked shingles present

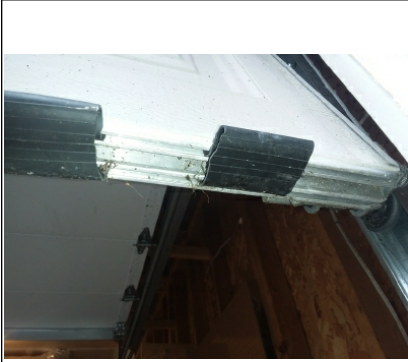
The overhead garage door weather-stripping is damaged/missing, recommend license garage door technician to install new weather stripping to prevent rodent access and or cold air draft

Damaged garage door weather stripping

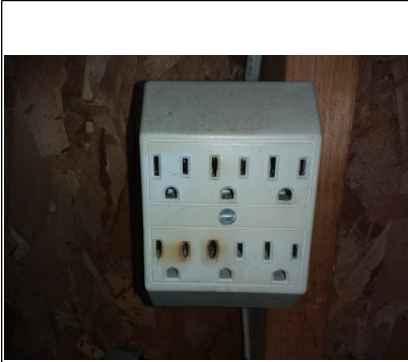
Comments One electrical receptacle in the garage show signs of overheating, recommend to replace with new plug

Overheated electrical receptacle

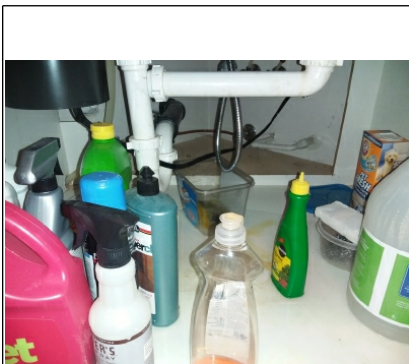
Comments Kitchen sink drain leaks, recommend to try to tighten drain pipes

Kitchen sink drain leaks

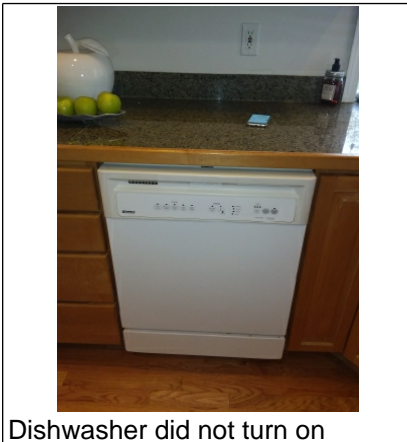
Comments Dishwasher did not turn on

Dishwasher did not turn on

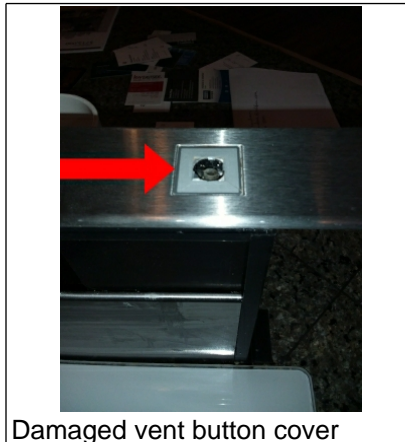
Damaged vent button cover

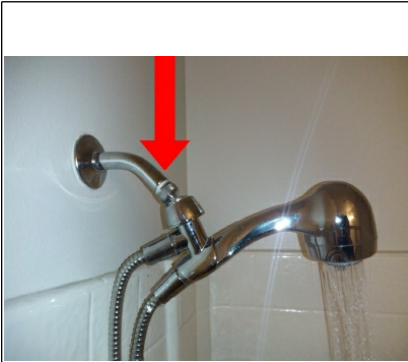
Bathroom shower faucet is leaking, recommend applying new Teflon tape and tightening

Leaking shower head

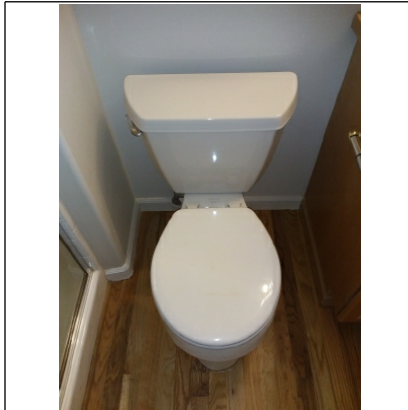
Water turned off to the toilet

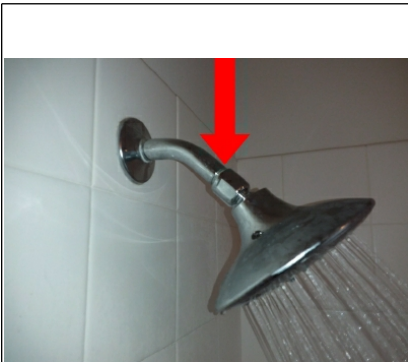
Shower head leaks

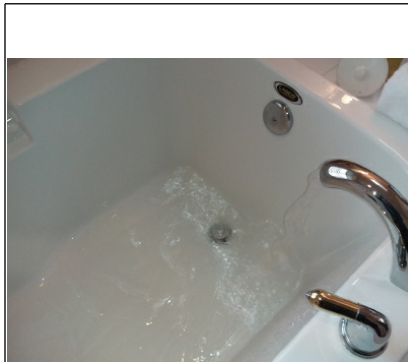
Comments Master bathroom tub is slow to drain, recommend drain opener to see if that solves the problem
 Master bathroom shower faucet leaking, recommend applying new Teflon tape and tightening

Bathtub slow to drain

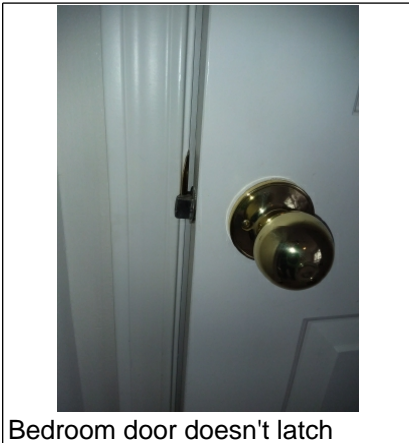
Comments Bedroom door does not latch, recommend to adjust strike plate

Bedroom door doesn't latch

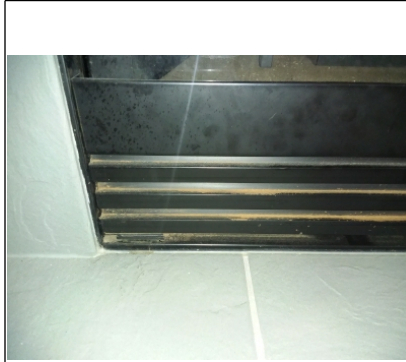
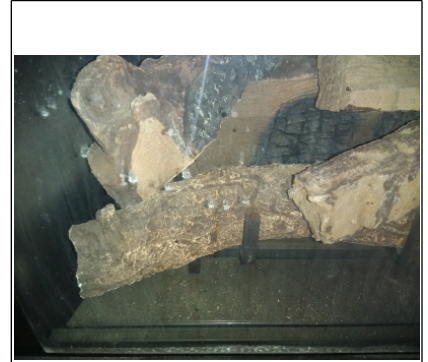
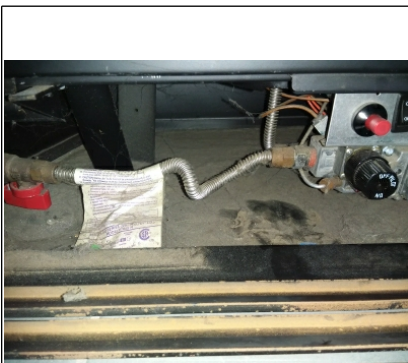
Comments Dust and dander present with a cold draft from under the gas fireplace, moisture streaks on glass front, gas pilot light was unable to ignite, recommend license fireplace technician evaluate

Cold draft from under fireplace

Moisture stains inside fireplace glass

Dust and dander inside of fireplace

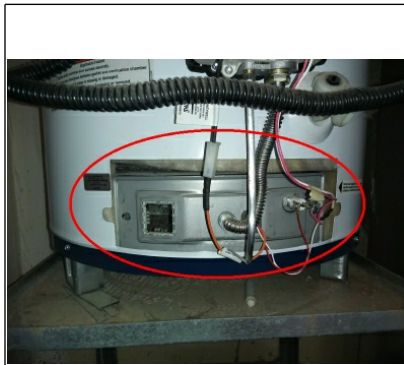
Missing cover

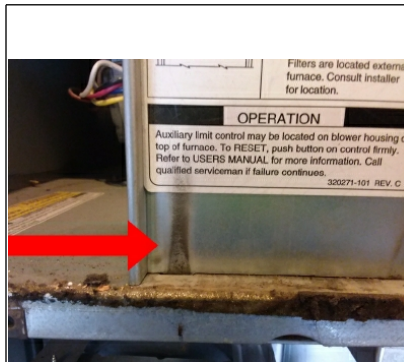
Comments It appears that the furnace has never been serviced, extremely dirty furnace filter that is completely clogged is present, rusting vent pipe, furnace did not fire when the thermostat was turned on, recommend license HVAC technician to evaluate, clean, and recommend maintenance

Burn mark in furnace

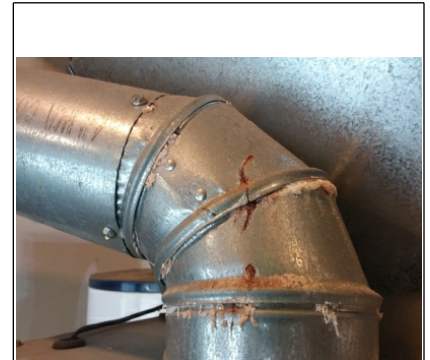
Rust present on furnace vent pipe

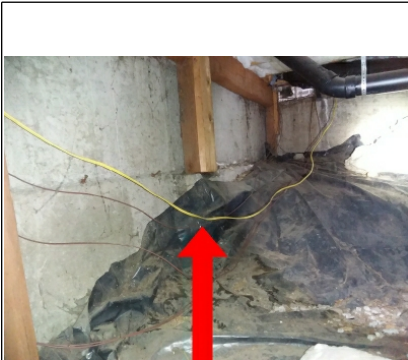
Comments Unsecured electrical wire present in the crawl space, recommend attaching to the floor joist

Unsecured electrical wire

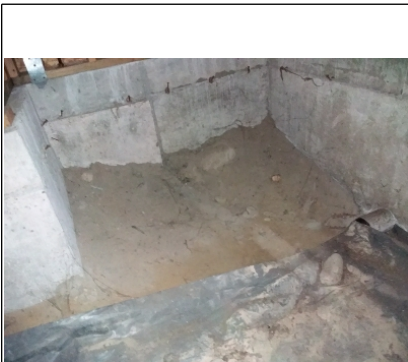
Comments Not all soil covered with adequate plastic vapor barrier, recommend covering all Earth with minimum 6 mil plastic sheeting

Missing vapor barrier

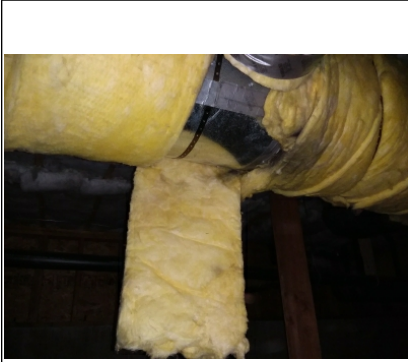
Some ducting insulation has become displaced, recommend to reattach as needed

Displaced ducting insulation
