Home Inspection Report

2112 Rush Street, Redmond, WA 98052

Wednesday May 1, 2019

2169

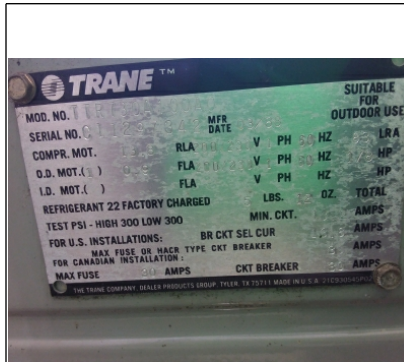
Compressor information

Firewood stacked up against compressor

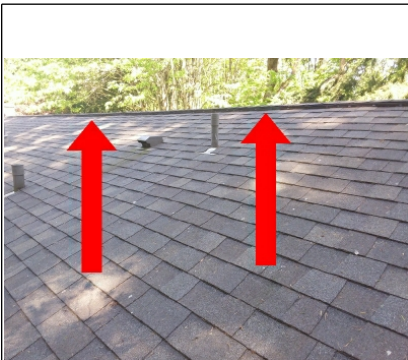
View of ridge vent

Comments Ridge vent added too roof possibly to mitigate organic growth inside of the attic

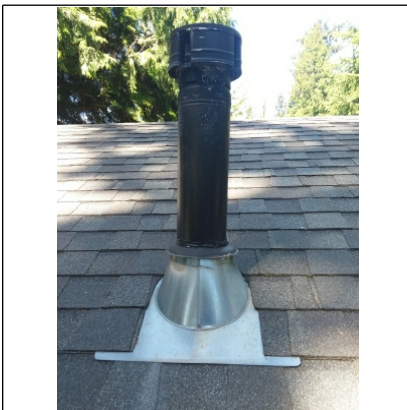
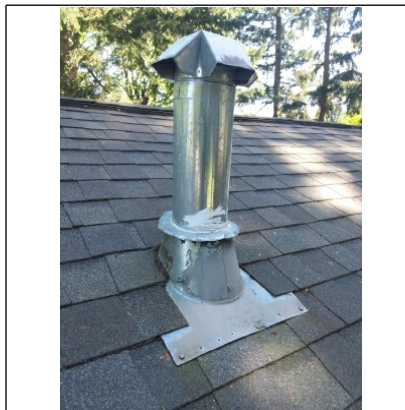
View of gas vent chimney

Comments Cracked caulking present on chimney flashing, recommend caulking as needed

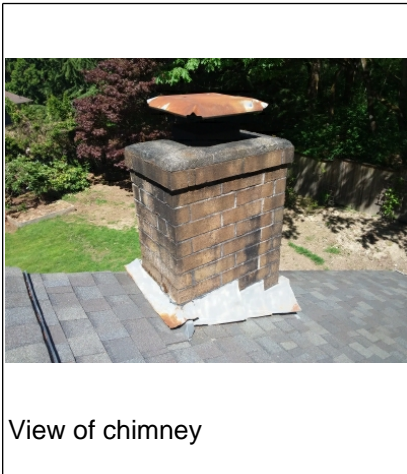
View of chimney

Comments Masonry chimney has some moss present with deteriorating chimney flashing caulking present, recommend cleaning moss and recaulk flashing as needed

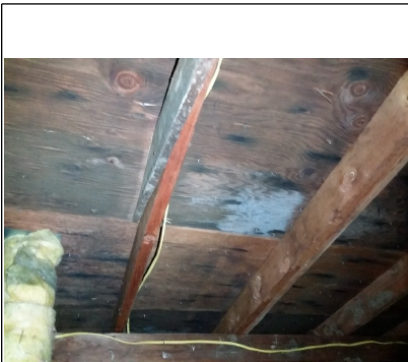
View of roof underlayment

Light and dark organic growth present on plywood roof underlayment in the attic, recommend licensed mold inspector to evaluate

Dark staining present possible mold

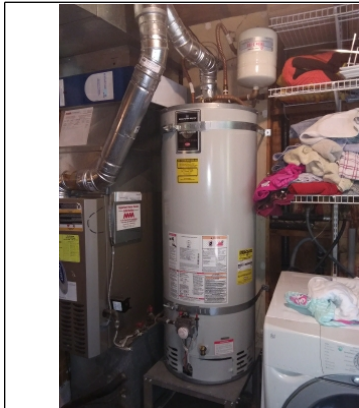
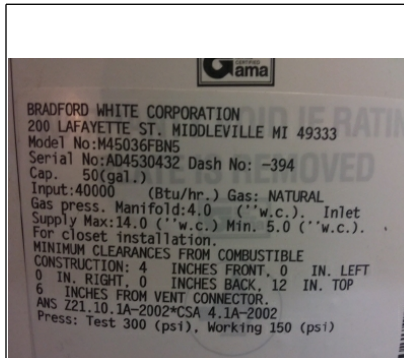
View of water heater

Comments Water heater expansion tank internal rubber diaphragm is leaking, gas vent pipe is two different types of piping held together by sheet metal screws, recommend licensed plumber to evaluate and repair

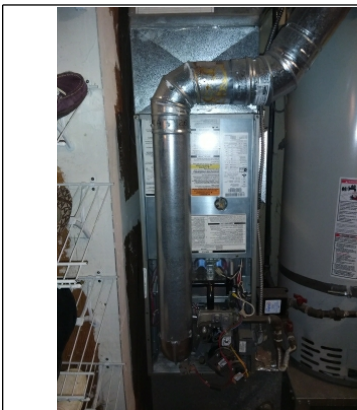
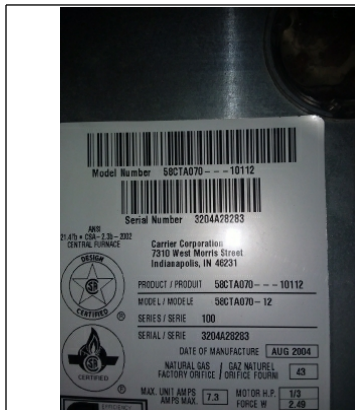
View of furnace

Comments Soot and effervescence present in the furnace with two different types of gas vent ducting used with some deterioration present, recommend license HVAC technician to evaluate, clean and repair as needed

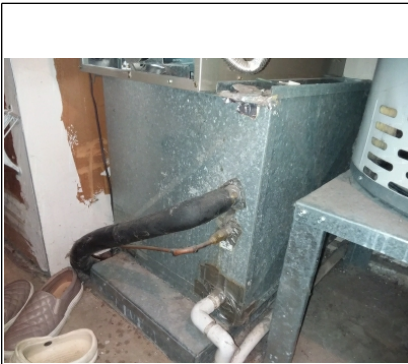
View of air conditioning evaporator

Comments Air conditioner evaporator and condenser are over 30 years old, warm air leaking out of multiple locations of evaporator located under the furnace, recommend license HVAC technician to evaluate when servicing the furnace

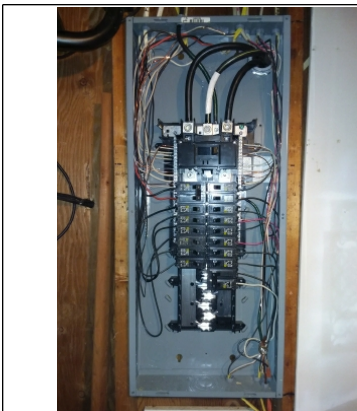
View of electrical service panel

Comments electrical service panel appears to have been installed unpermitted, solid core aluminum wires are present for branch wiring, evaluation of the electrical system by an electrician who has knowledge of and experience with solid conductor aluminum wiring is recommended

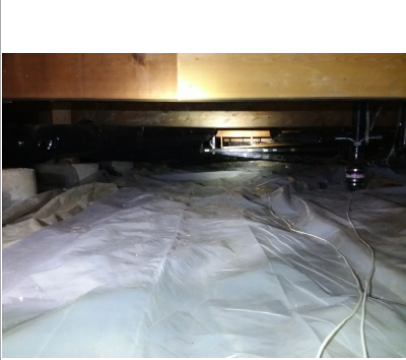
View in crawl space

Comments Deteriorating cast iron waste water drain pipe with puddle of raw sewage present in the crawl space, improperly installed ABS bathtub drain pipes with small leak present, recommend licensed plumbing contractor to evaluate
