Home Inspection Report

1276 145th Ave SE, Bothell, WA 98021

Wednesday April 10, 2019

2615

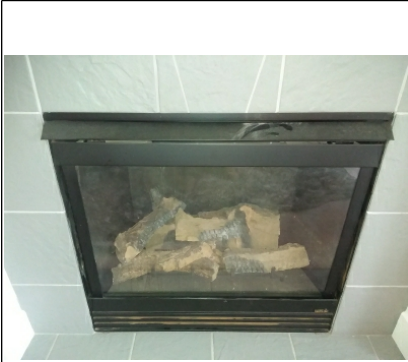
Comments Dust and dander present with a cold draft from under the gas fireplace, moisture streaks on glass front, gas pilot light was unable to ignite, recommend license fireplace technician evaluate

View of gas fireplace

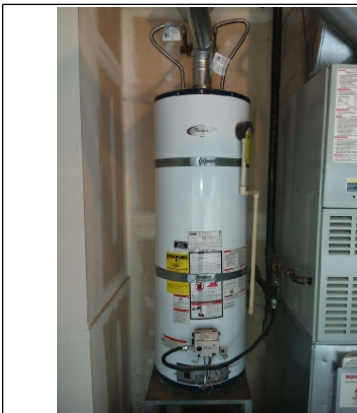
Comments Water temperature tested at 113 degrees

View of water heater

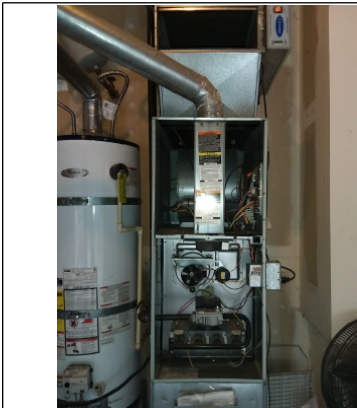
Comments It appears that the furnace has never been serviced, extremely dirty furnace filter that is completely clogged is present, rusting vent pipe, furnace did not fire when the thermostat was turned on, recommend license HVAC technician to evaluate, clean, and recommend maintenance

View in furnace
